Introduction

Thank you for participating in the Spartan®-6 FPGA Engineering Sample Program. As part of this program, we are pleased to provide to you engineering samples of the device listed in [Table 1](#). Although Xilinx has made every effort to ensure the highest possible quality, this device is subject to the limitations described in the following errata.

Table 1: Device Affected by These Errata

Device	JTAG ID (Revision Code)
XC6SLX16-2CSG324CES	1

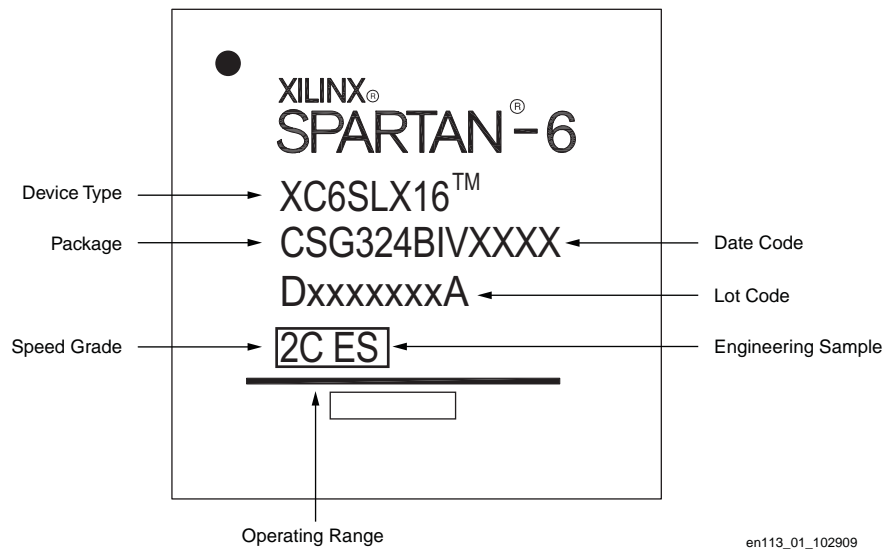
Figure 1: XC6SLX16-2CSG324CES Marking

The XC6SLX16 listed in Table 1 is marked as shown in Figure 1.
